LOGGING THE CHALK

TYPICAL CHALK CORE LOGS WITH EXAMPLES
OF WEATHERING AND CIRIA GRADE

CABLE PERCUSSION DRILLING: LOGGING
U100 CHALK SAMPLES

SONIC DRILLING IN CHALK

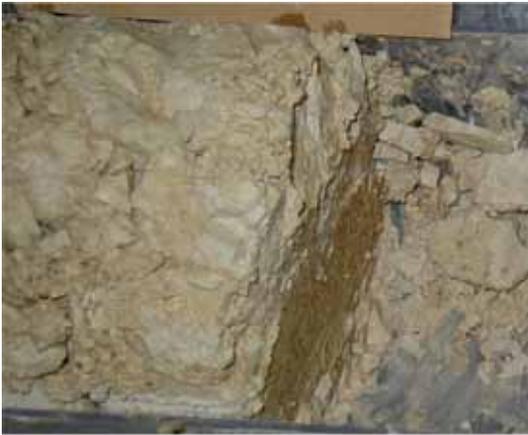
Moderately stained and polished sub-horizontal joint (open < 3mm)
CIRIA grade B and orange-stained chalk

Figure C18 Details from the West Marden Borehole chalk cores illustrating structured weathered chalk CIRIA grades C to B.

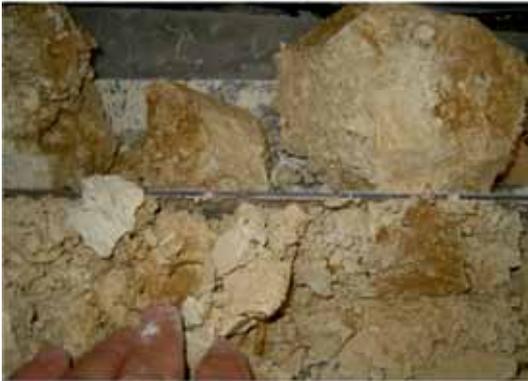
Moderately to heavily stained and clay-filled joints (open > 3mm)
CIRIA grade C and orange-stained softened chalk

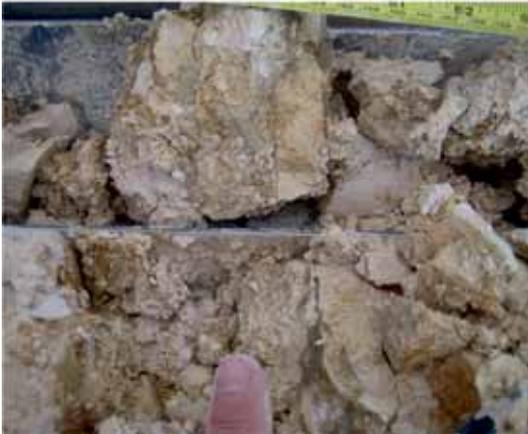
Moderately to heavily stained and clay-filled joints (open > 3mm)
CIRIA grade C and orange-stained and softened chalk

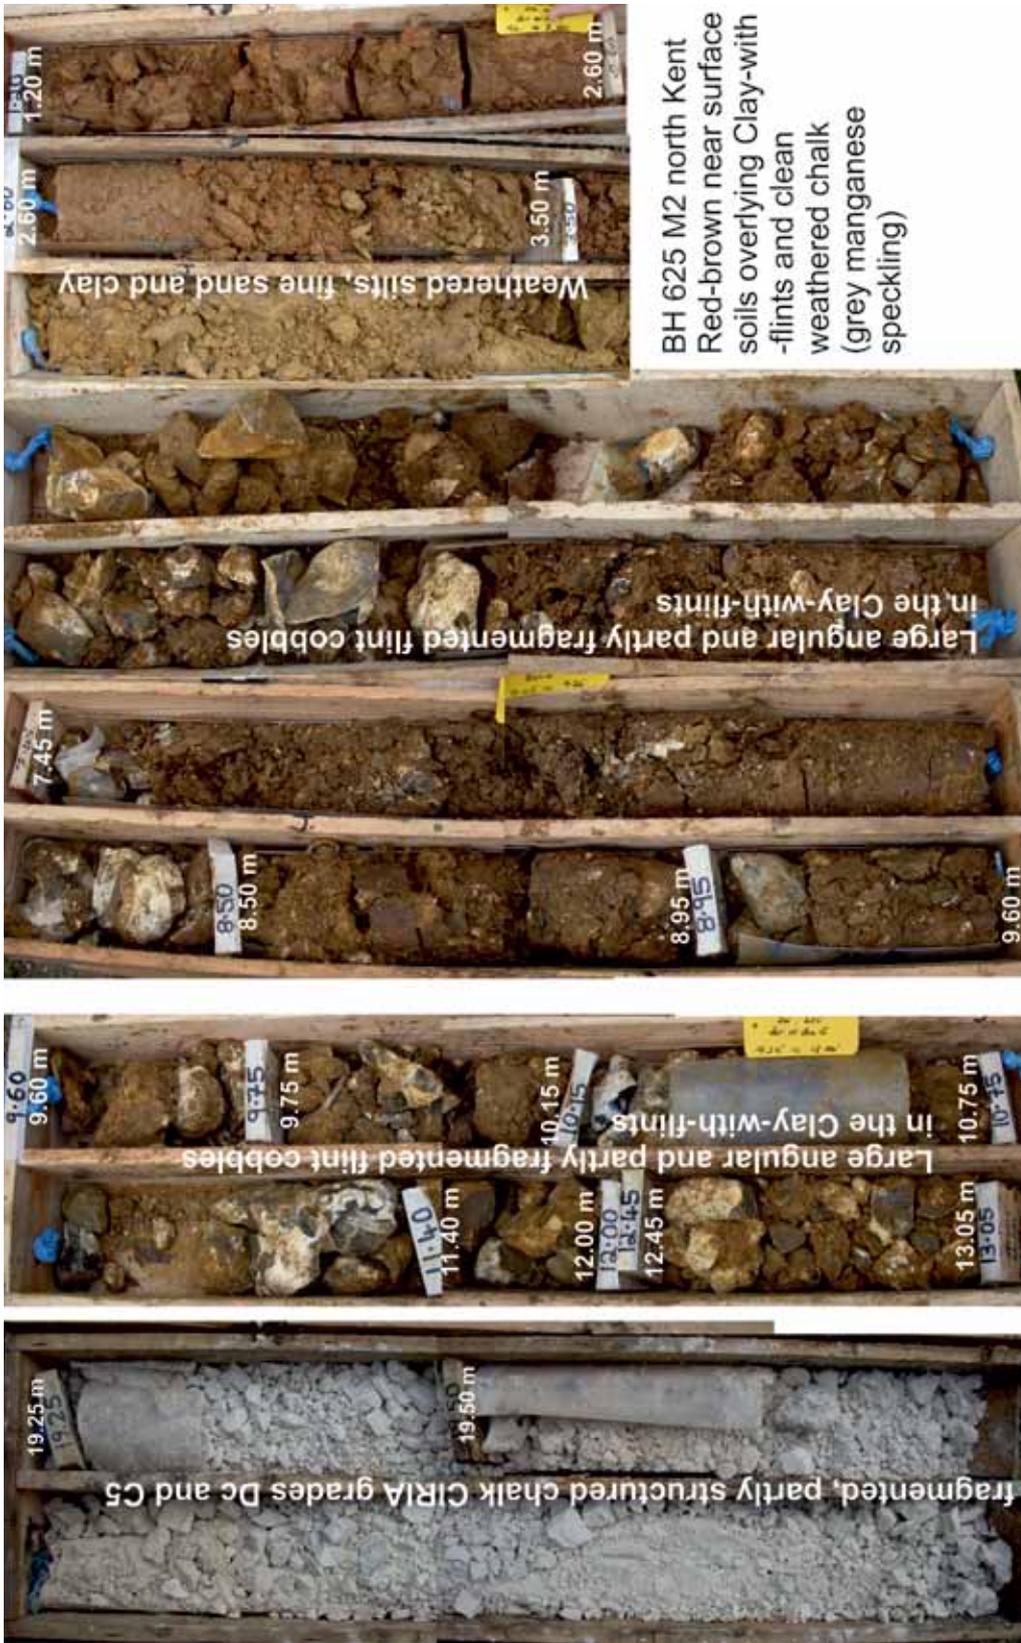
Figure C19
Fragmented chalk core from destructured CIRIA grade D chalk from beneath Quaternary clay-with-flints.

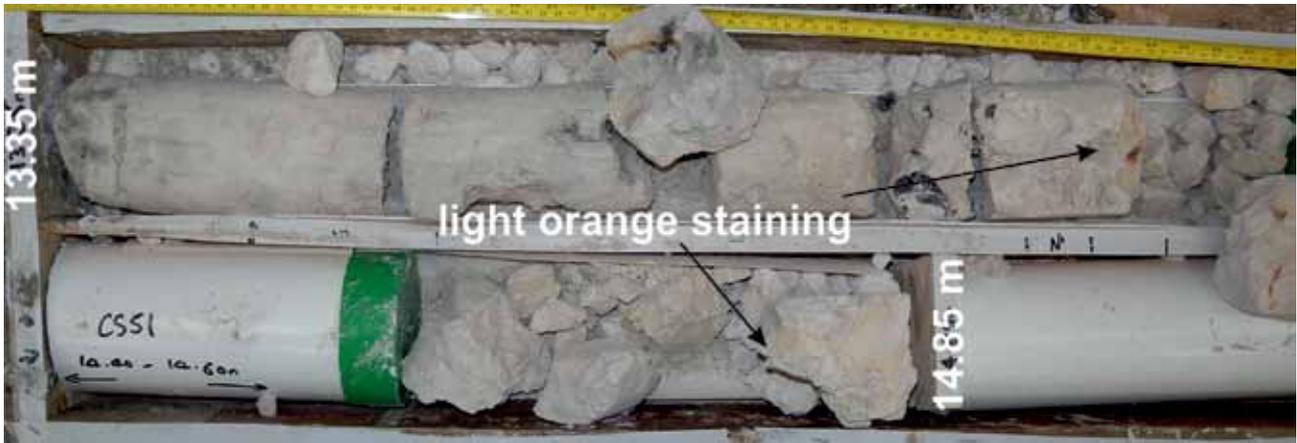
Figure C5a3 Relatively unweathered chalk at the contact between the Chalk and Thanet Sands (CIRIA grade B) and core destructured by drilling. Light orange staining on joints and internally in the Chalk.

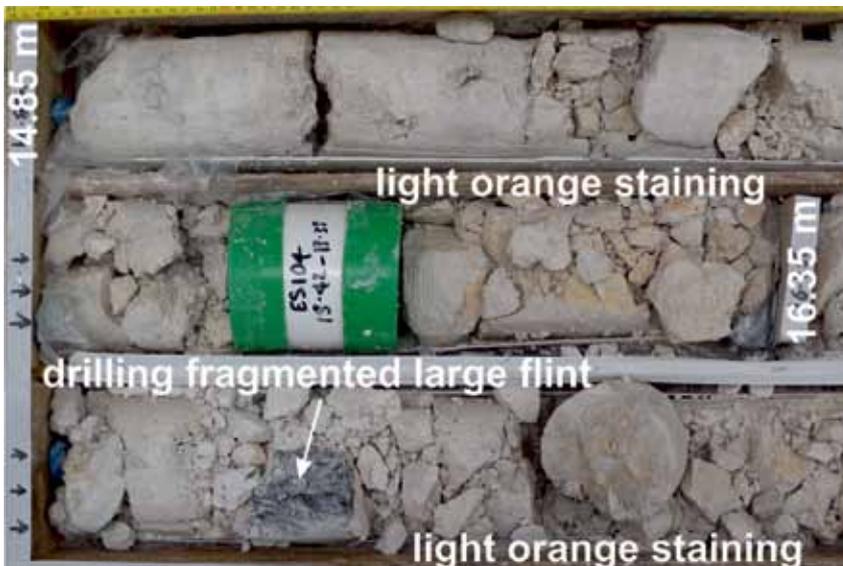
Figure C5a5 Relatively unweathered chalk at the contact between the Chalk and Thanet Sands (CIRIA grade B) and core destructured by drilling. There is light orange staining on joints and internally in the Chalk core.

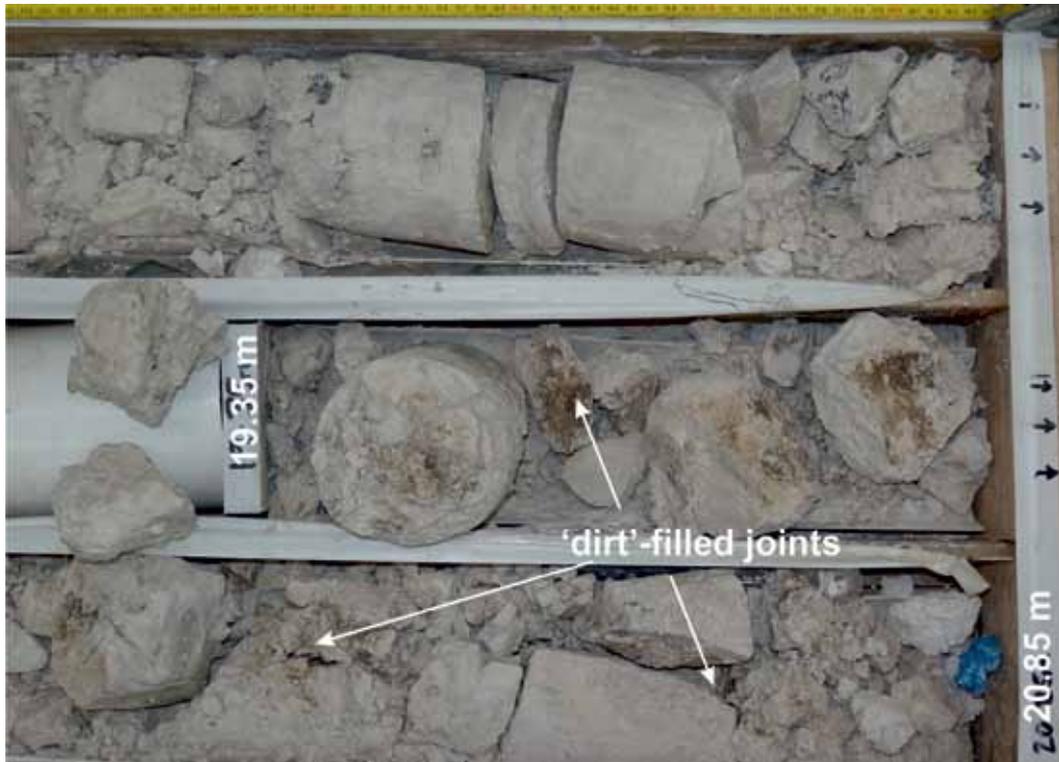
Figure C5a9 Dirt-filled 'open' joints, CIRIA grade C.

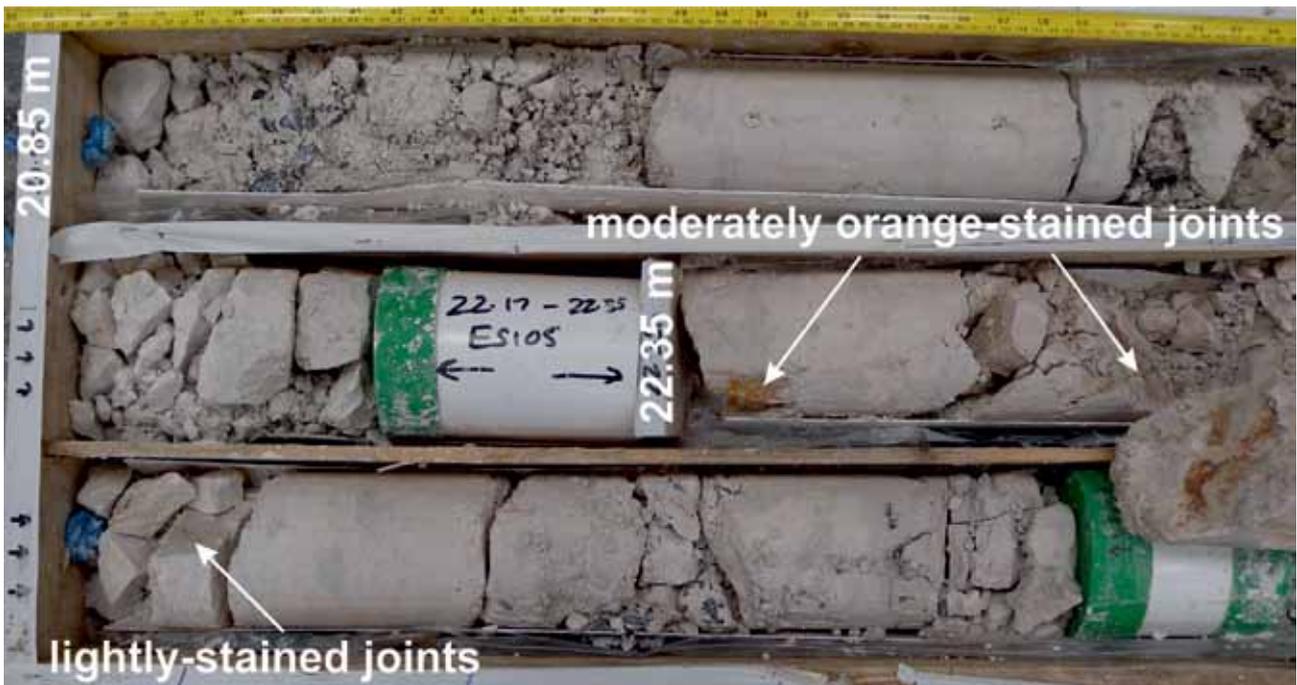
Figure C5a10 Moderately stained 'slightly open' joints, CIRIA grade B chalk.

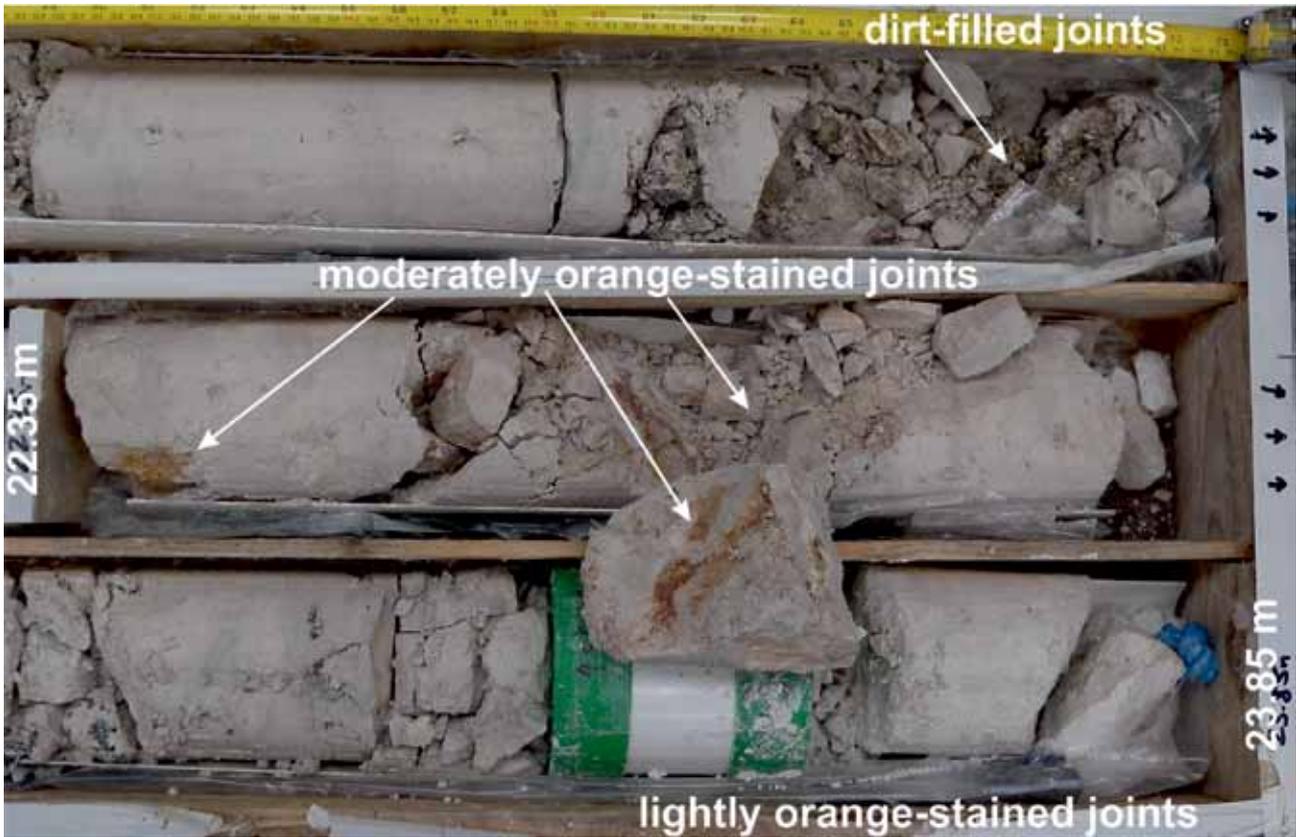
Figure C5a11 Moderately stained 'slightly open' joints, CIRIA grade B and dirt-filled open joints grade C chalk.

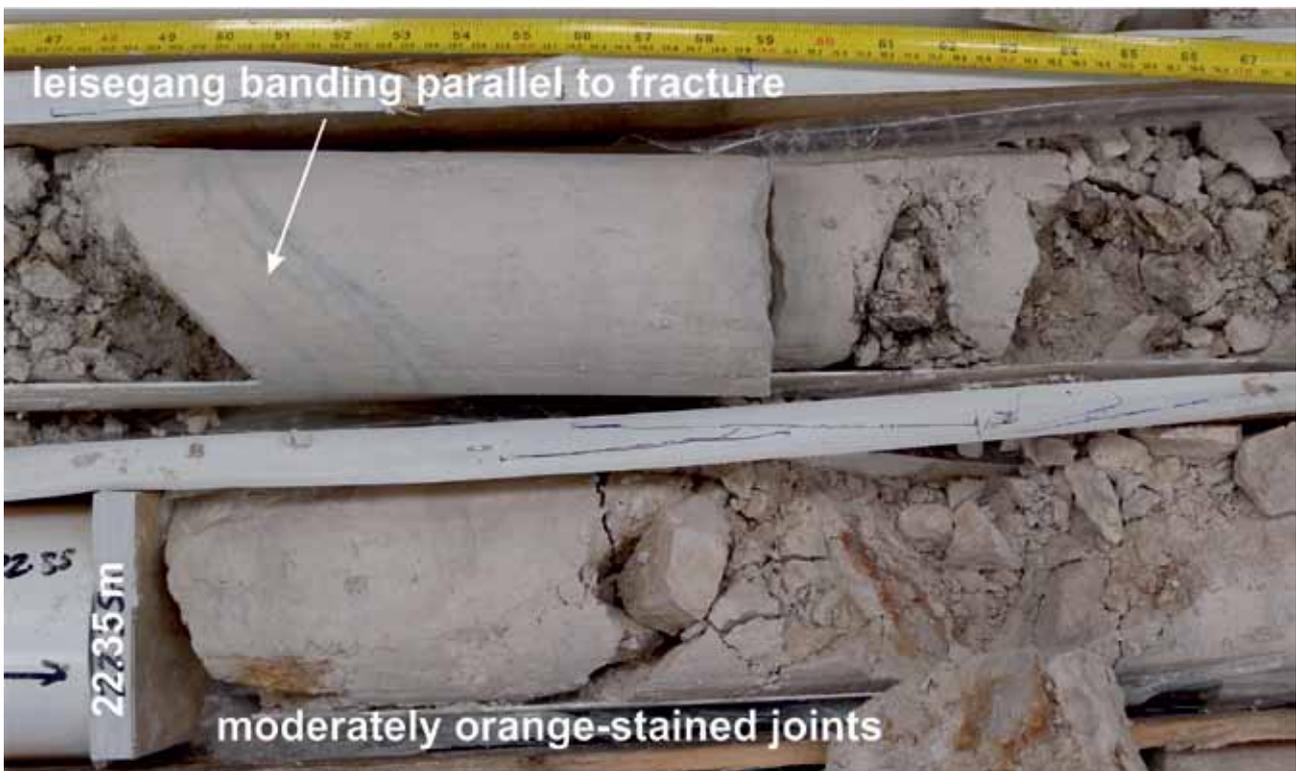
Figure C5a12 Moderately stained 'slightly open' joints, CIRIA grade B, and dirt-filled open joints, grade C. Liesegang banding internally in the chalk is parallel to a fracture (indicating groundwater movement).

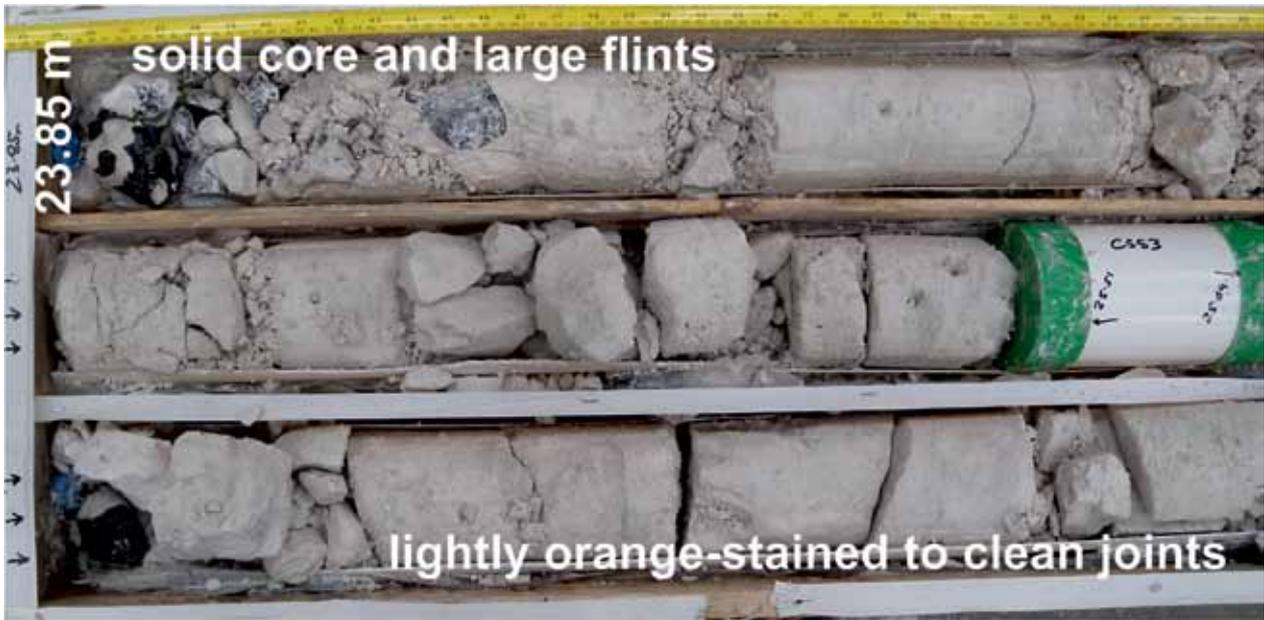
Figure C5a13 Continuously solid core (mostly drilling-induced fractures) with large flints and clean, closed joints, CIRIA grade A.

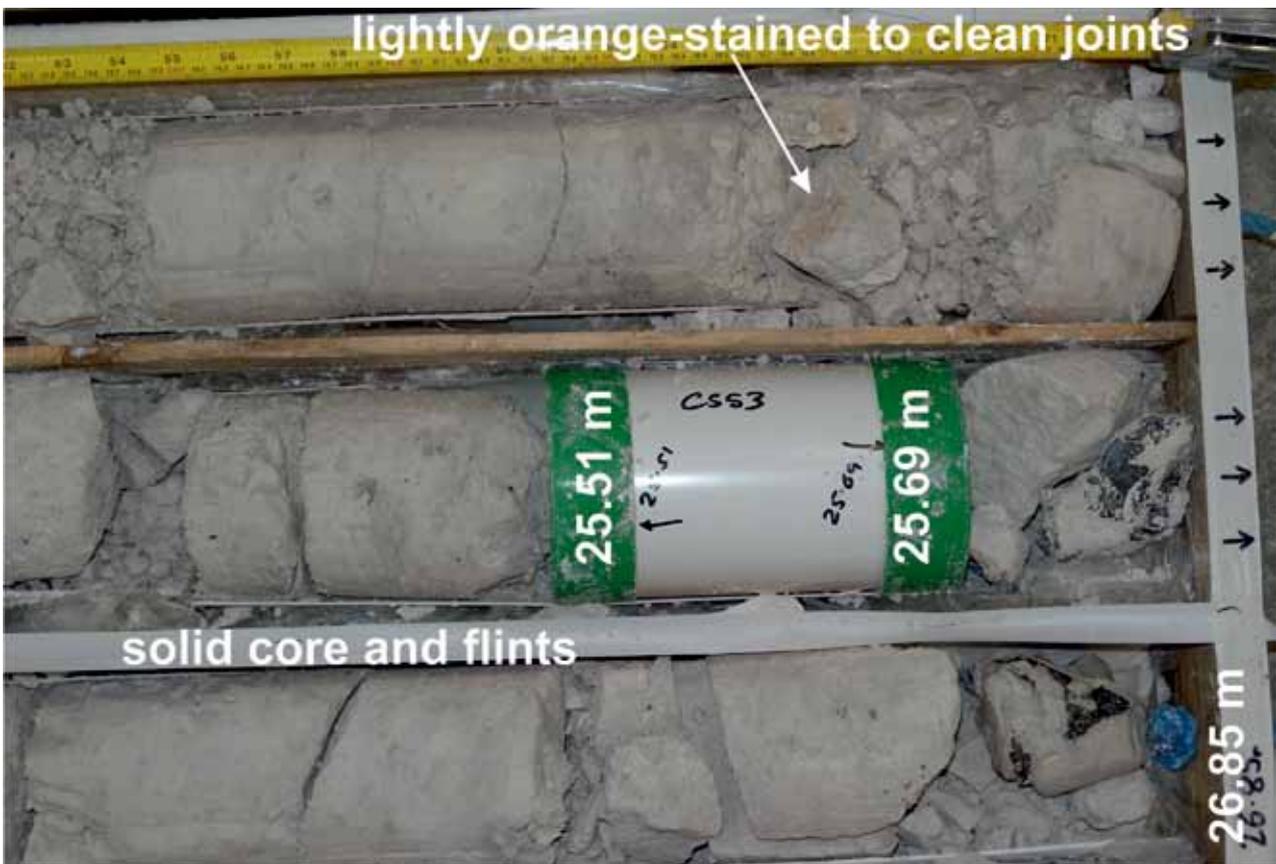
Figure C5a14 Continuously solid core (mostly drilling-induced fractures) with large flints and clean to lightly orange-stained closed joints, CIRIA grade A.

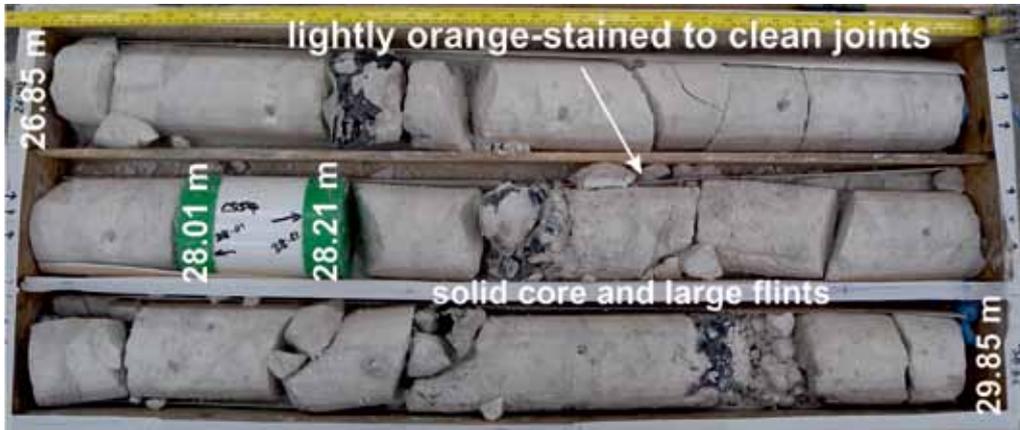
Figure C5a15 Continuously solid core (mostly drilling-induced fractures) with large flints and clean closed joints, CIRIA grade A.

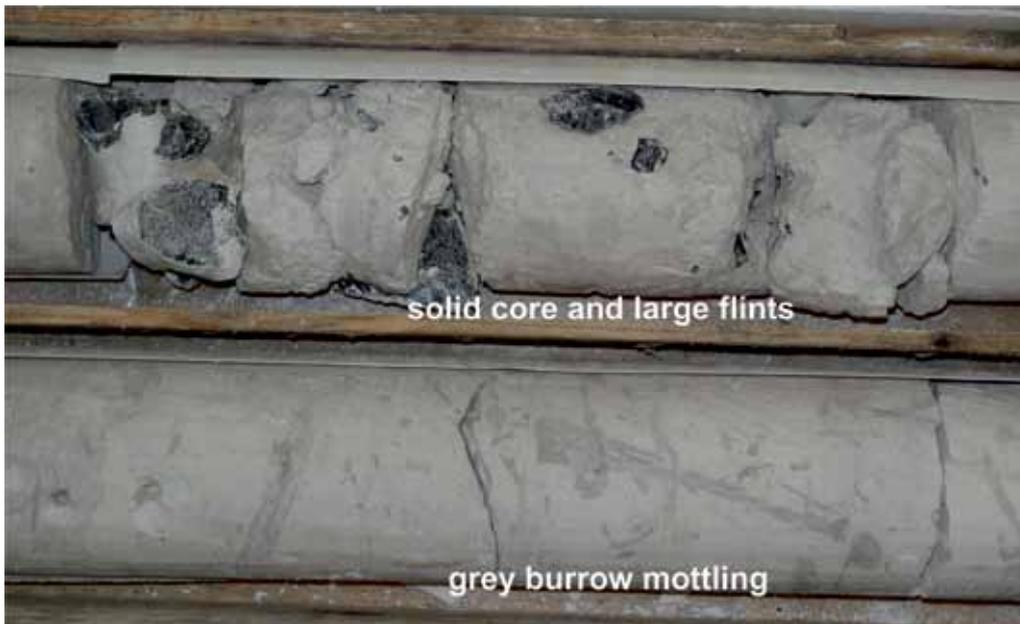
Figure C5a17 Continuously solid core (mostly drilling-induced fractures) with large flints and clean closed joints, CIRIA grade A with abundant light grey trace fossils (burrow-mottled chalk).

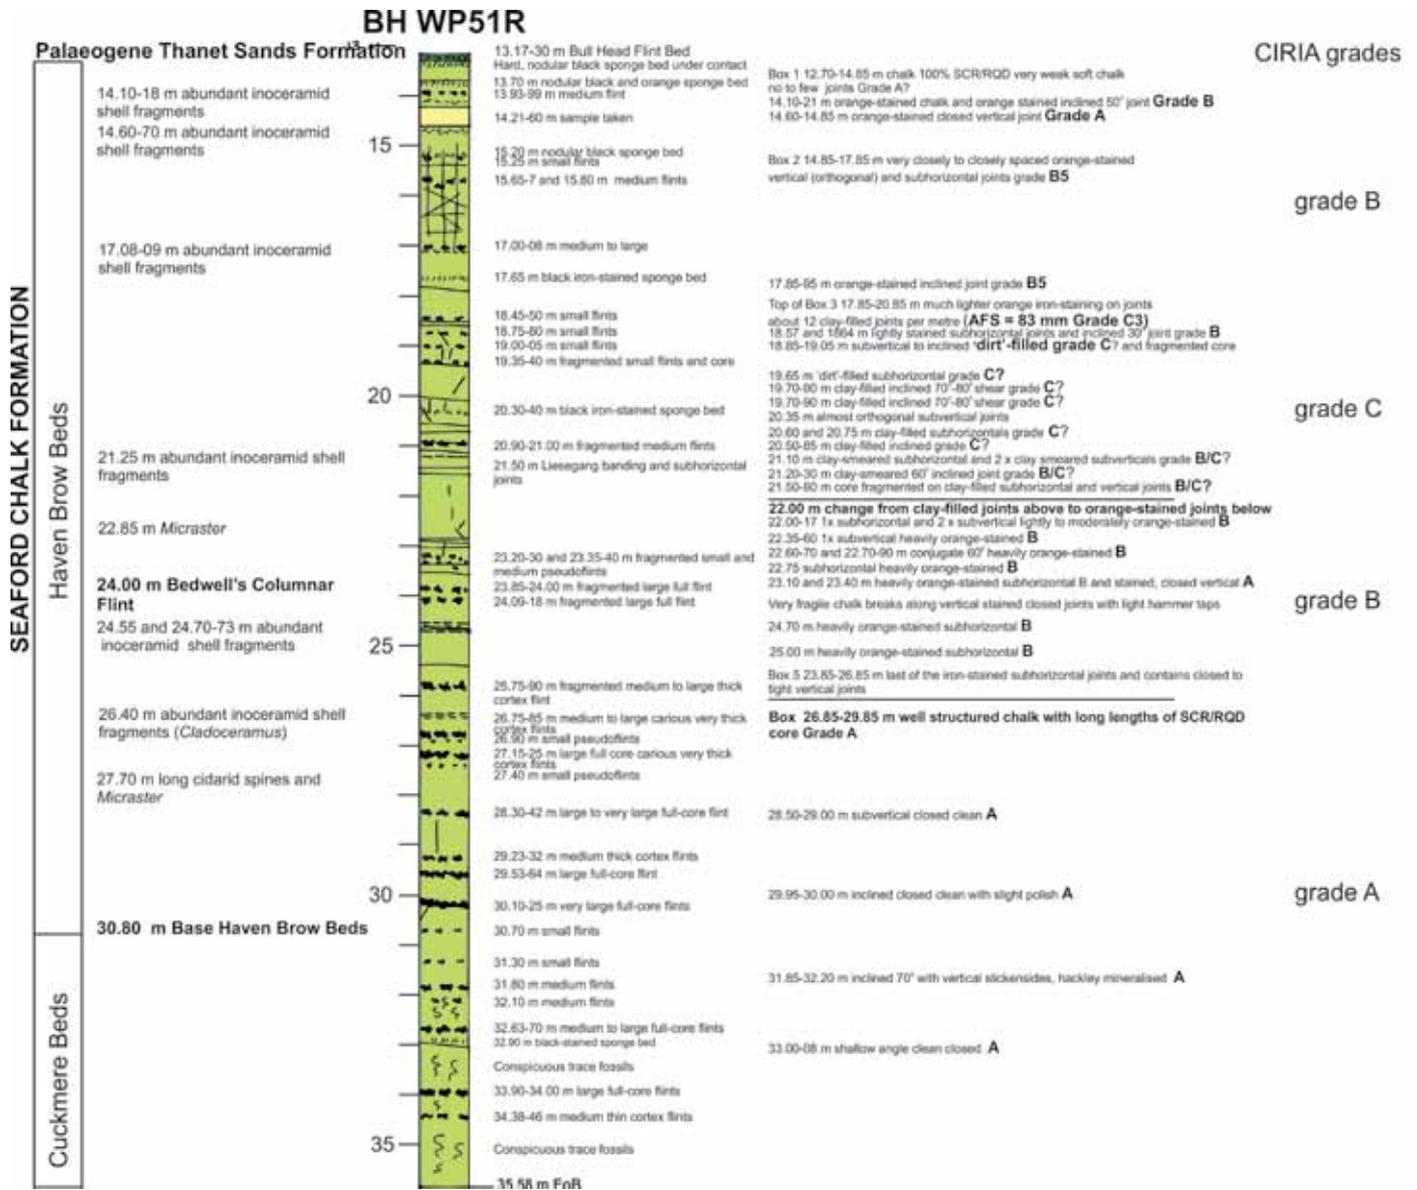
Figure C5a18 Borehole 5a log (East London), illustrating change of CIRIA grade with depth for the borehole cores illustrated in preceding figures.

Example of a typical Chalk core starting in relatively unweathered CIRIA grade B chalk passing down into CIRIA grade C chalk with filled fractures (Figures C5a1–C5a18).

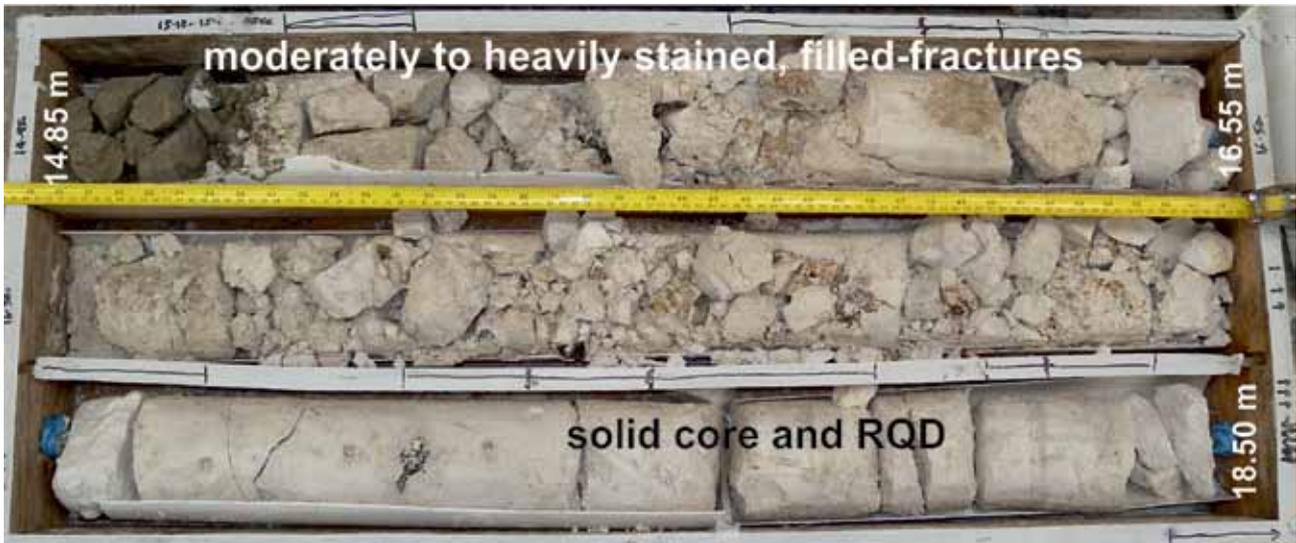
Figure C5b1 Fractures in first 2 m below Thanet contact are open >3 mm, stained and filled, hence CIRIA grade C.

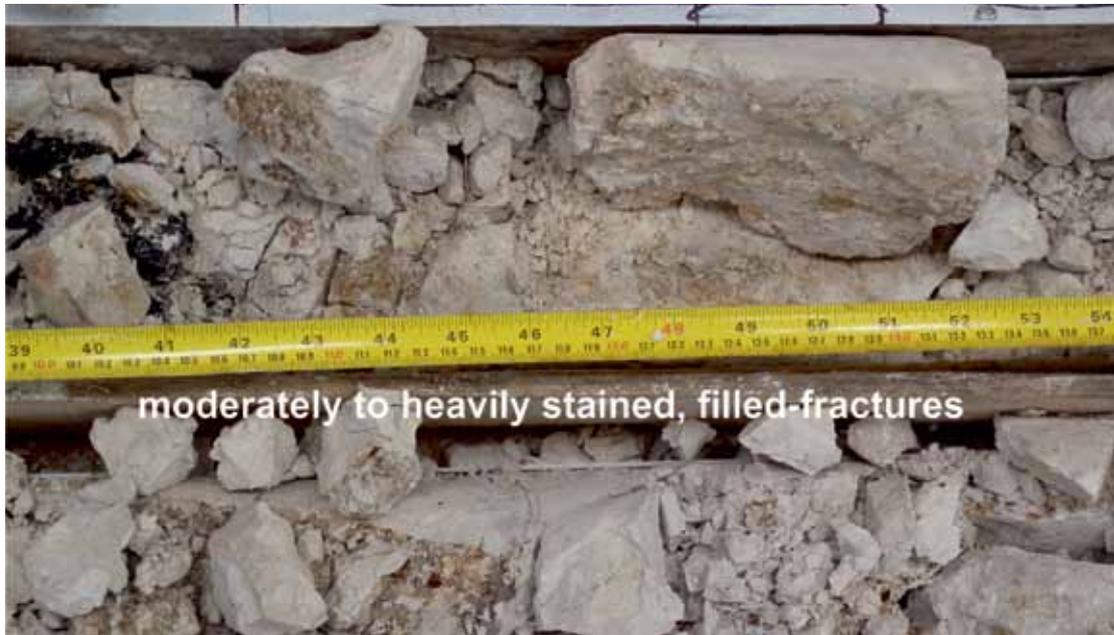
Figure C5b3 Fractures in first 2 m below Thanet contact are open >3 mm, stained and filled, hence CIRIA grade C.

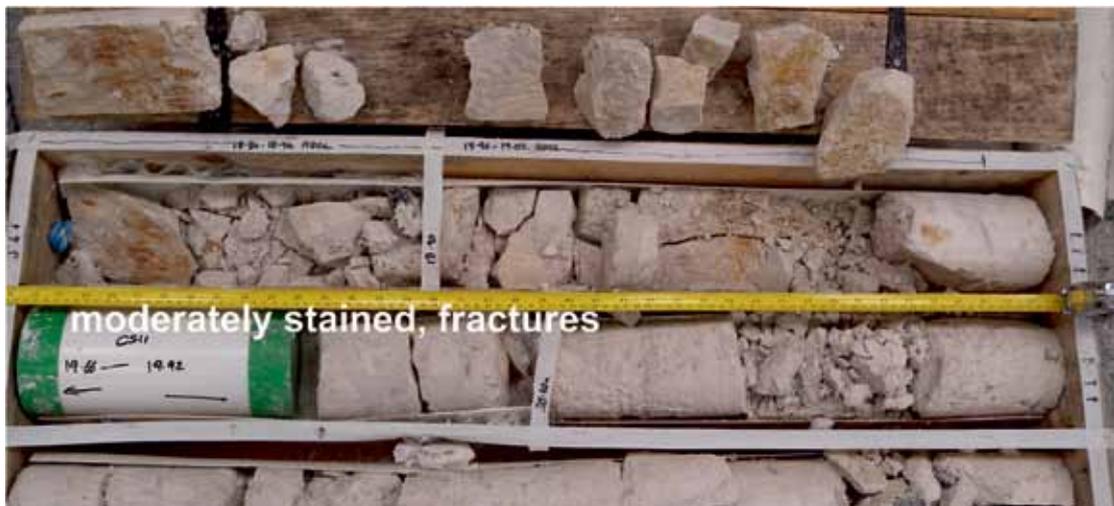
Figure C5b4 Next box fractures are open <3 mm, moderately stained, hence CIRIA grade B.

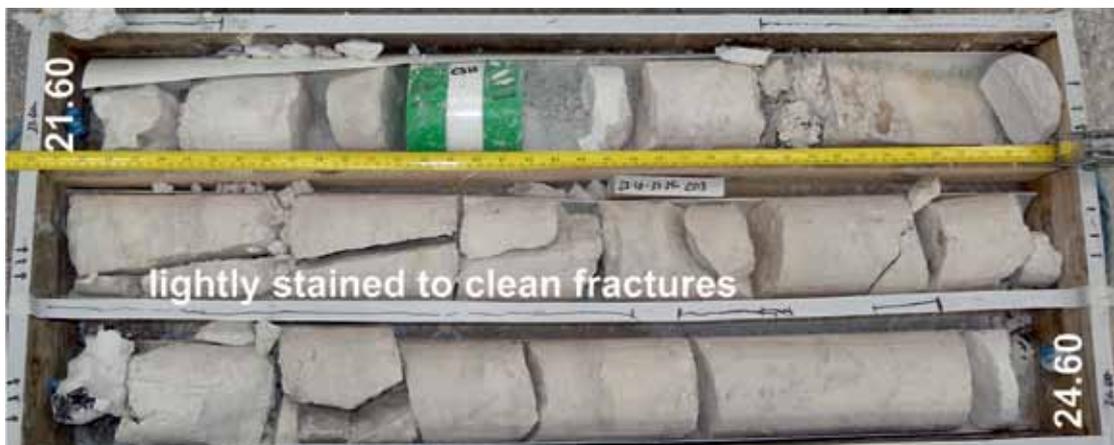
Figure C5b5 WP43R: next box fractures are closed to open <3 mm, clean or lightly stained, hence CIRIA grade A/B.

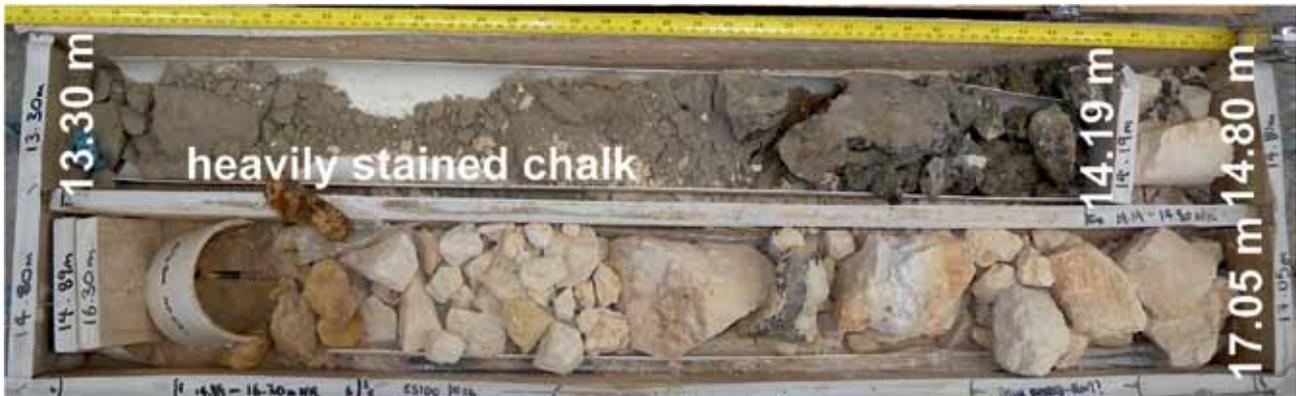
Figure C5c1 Box 2, heavily stained chalk and core loss. Despite the poor core recovery, a ‘blocky’ structure is retained and, combined with the staining, suggests CIRIA grade C.

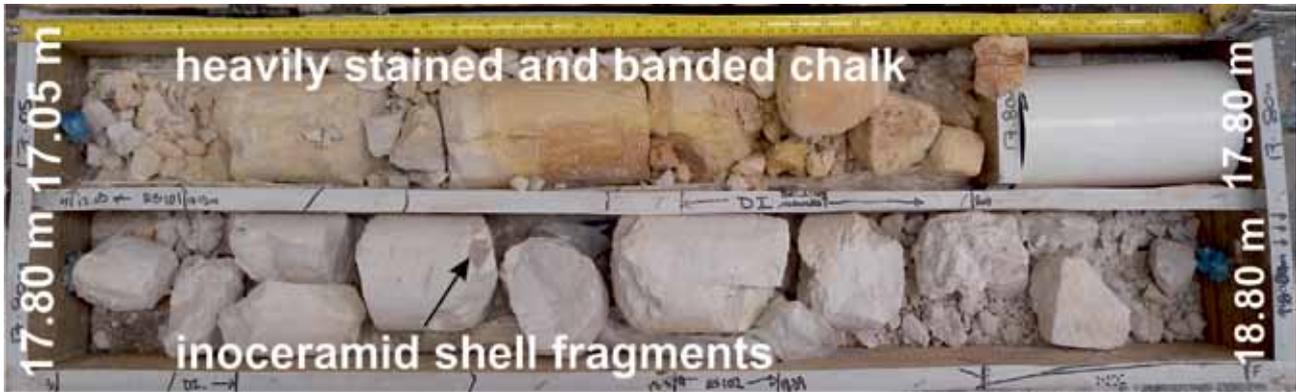
Figure C5c3 Box 3, heavily stained chalk with drilling-induced fractures and fragmentation and some solid core indicating structured chalk, CIRIA grade B.

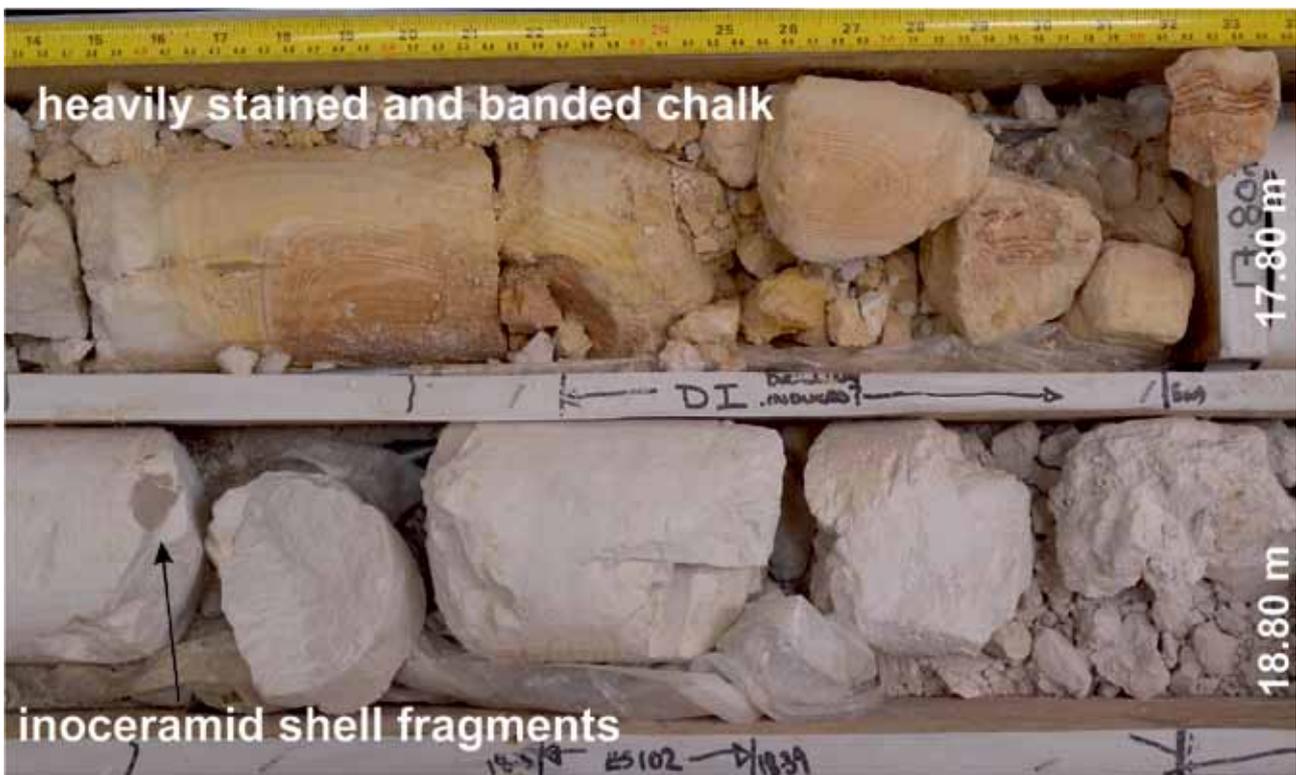
Figure C5c4 Close-up of box 3, heavily stained and banded chalk and vertical joint and some solid core with a closed vertical joint, CIRIA grade B, locally A.

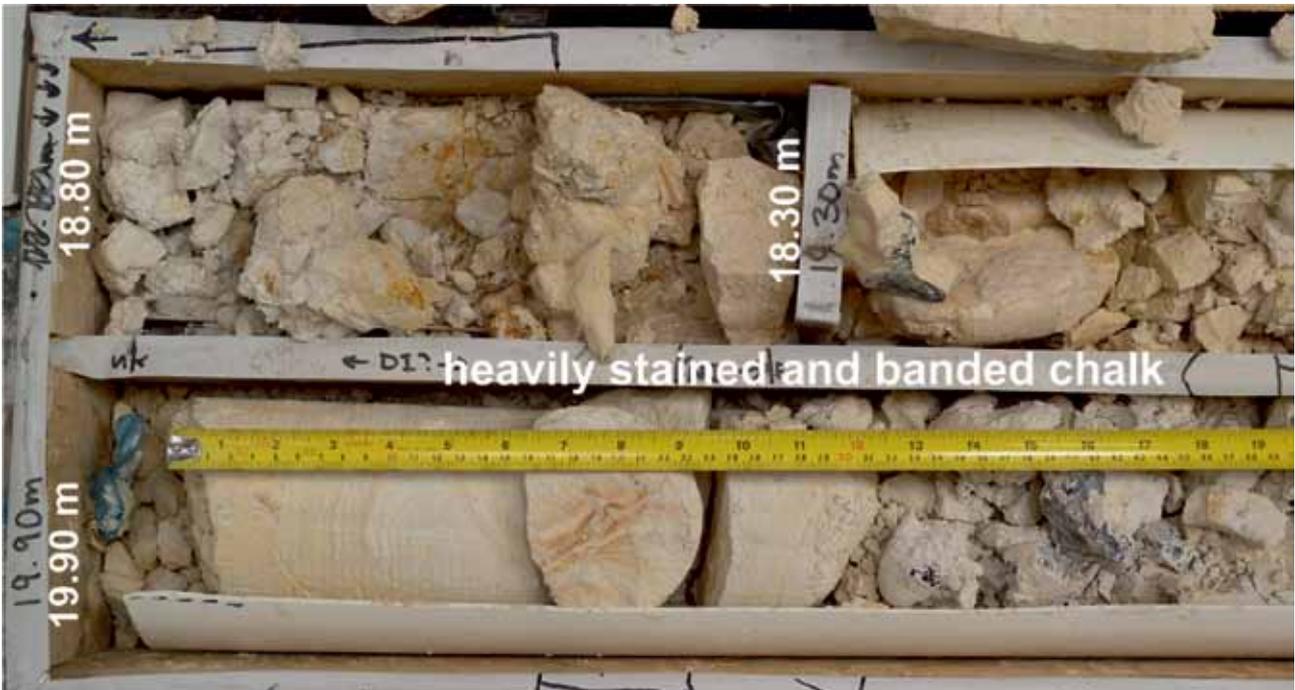
Figure C5c5 Box 4, heavily stained and Liesegang banded chalk and disintegrated core where flints are present. Some solid core with stained fractures, CIRIA grade B, locally C.

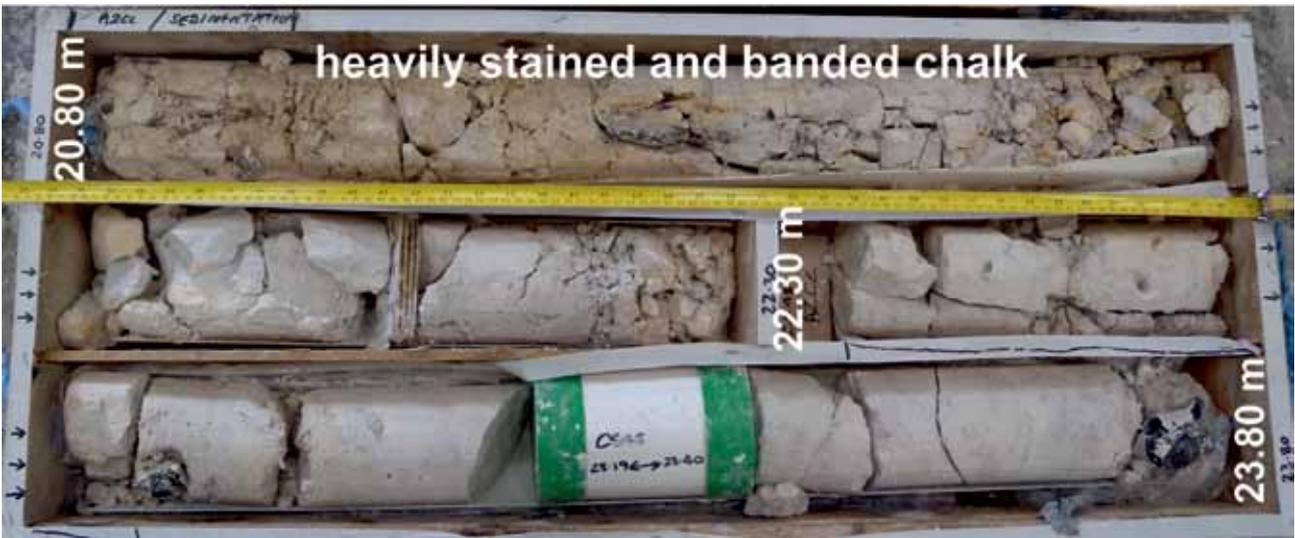
Figure C5c6 One core run with completely fragmented chalk with flints and heavily stained chalk (CIRIA grade B). Below 22.30 m depth the core runs comprise clean chalk with large flints and mostly drilling-induced fractures (CIRIA grade A).

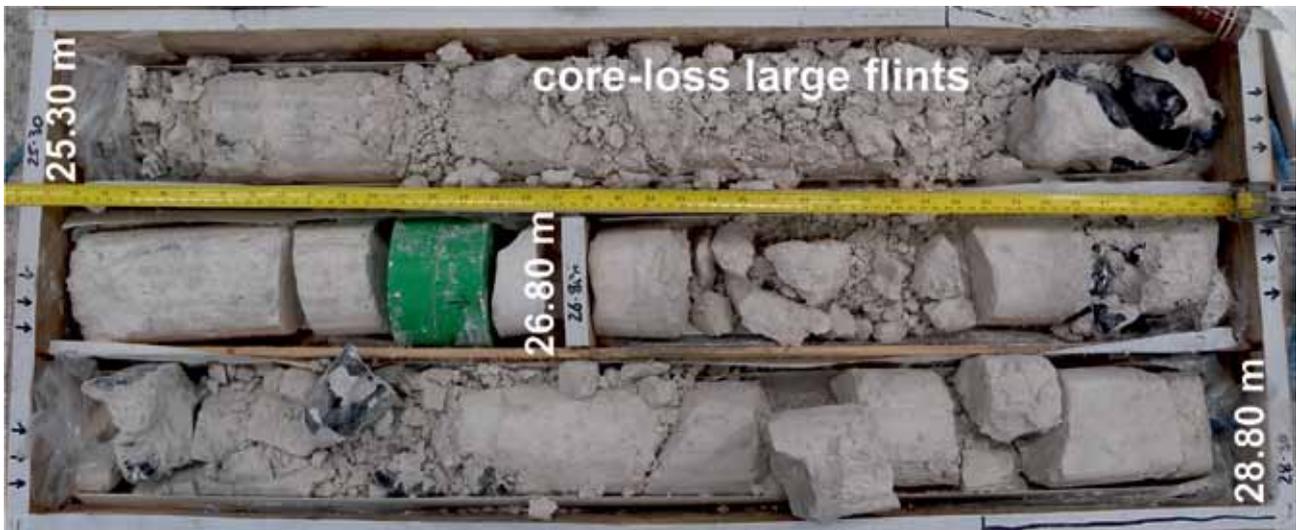
Figure C5c8 Box 7, very large flints in CIRIA grade A chalk. Core fragmentation due to drilling through flints.

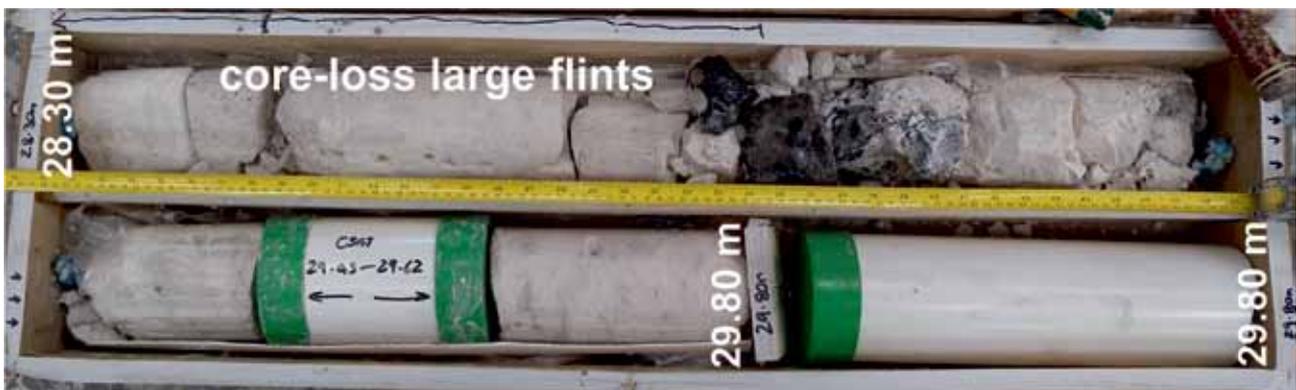
Figure C5c9 Box 8, very large flints in CIRIA grade A chalk.

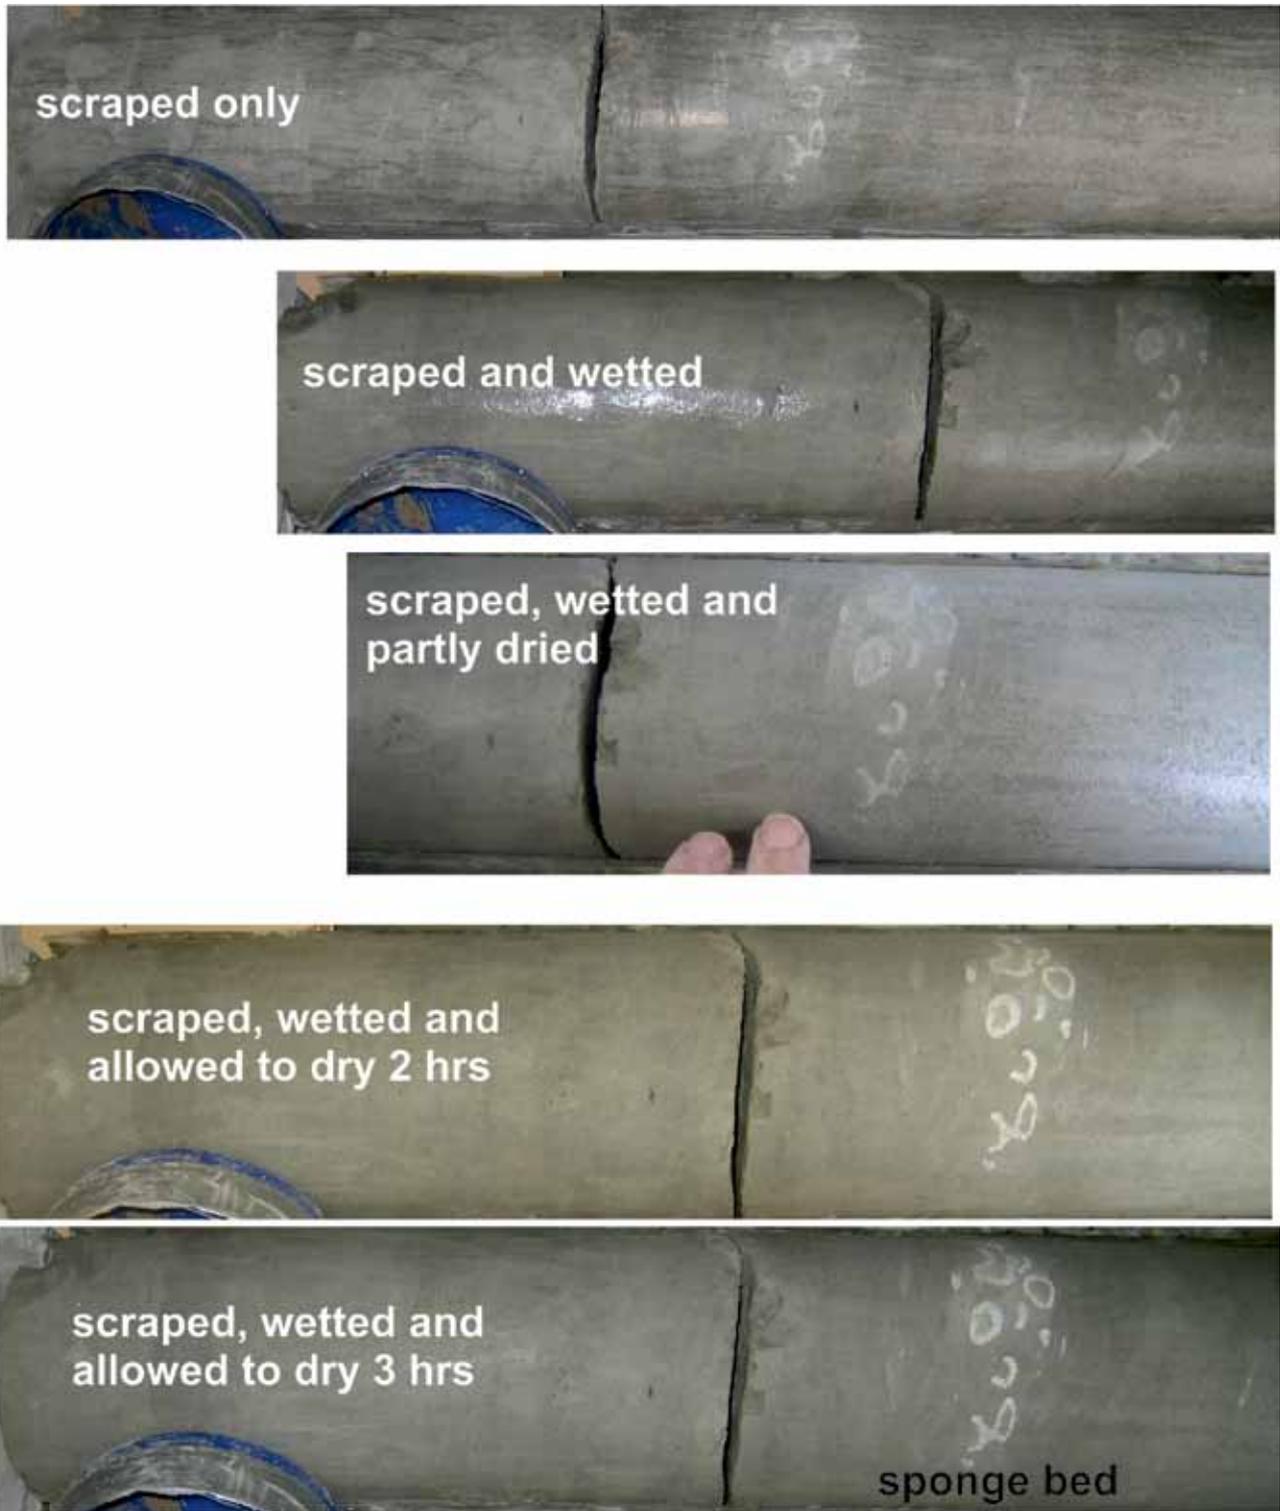
Figure C5d1 West Melbury Marly Chalk Formation core from Offham B borehole, Lewes, Sussex illustrating the enhancement of lithological detail as the core is scraped clean, washed with a squeeze bottle and allowed to dry.

It is essential to clean chalk core to obtain the necessary geological detail. For much of the White Chalk Subgroup, scraping the putty skin away is usually adequate. In some instances it is also necessary to wash the core clean (using a squeeze bottle, for example). For the West Melbury Marly Chalk Formation and parts of the Zig Zag Chalk Formation, even washing the core may be inadequate and, having been washed, the core needs to dry for about two hours before the detail becomes apparent (Figures C5d1 and C5d2).
