LOGGING THE CHALK

TYPICAL CHALK CORE LOGS WITH EXAMPLES
OF WEATHERING AND CIRIA GRADE

CABLE PERCUSSION DRILLING: LOGGING
U100 CHALK SAMPLES

SONIC DRILLING IN CHALK

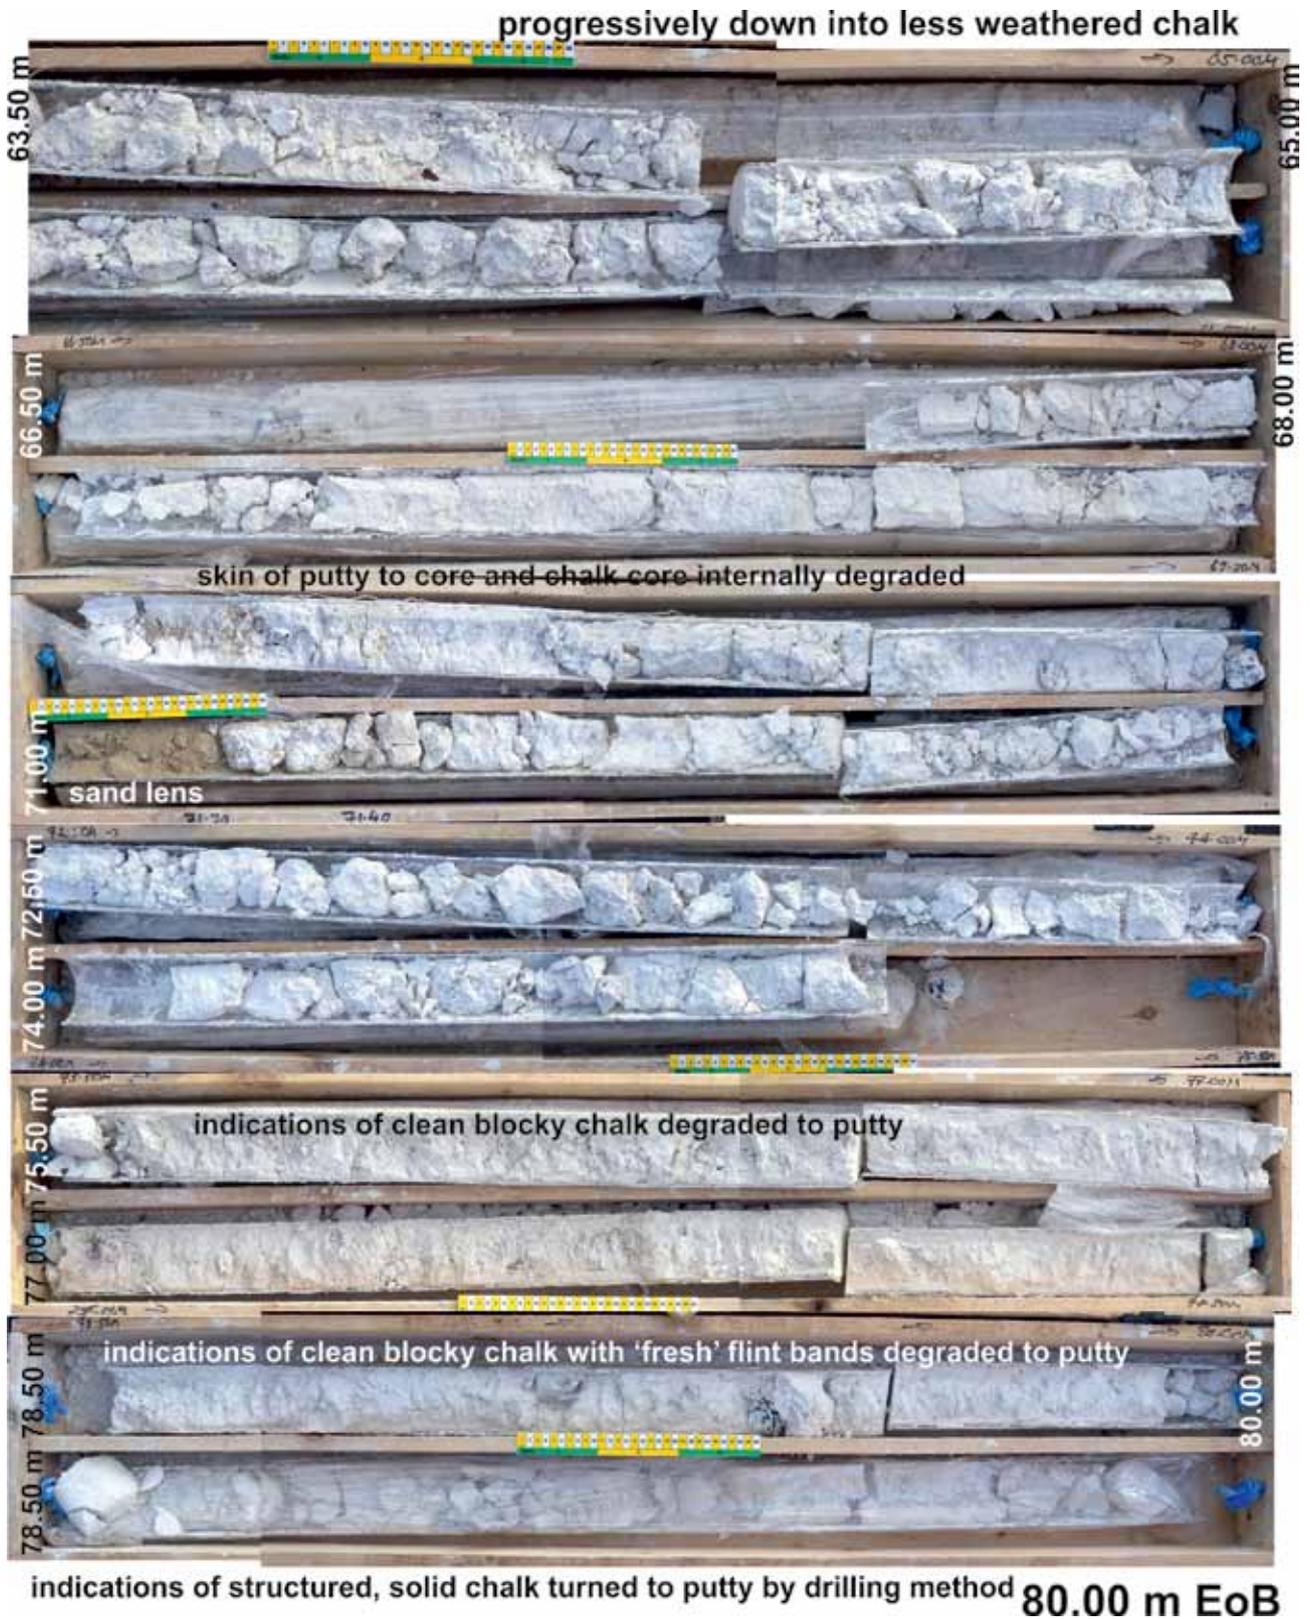
Figure E2. Examples of sonic core from chalk with 100% core recovery. However, there is little evidence of any structure in the chalk and the 'putty' matrix of fines increases downwards into what was probably better grades of chalk.

As a relatively new technology the technique of sonic drilling is bound to develop and it may be that experiments with different ranges of resonate energy, sizes of bits, drill string and liner will eventually yield reliable results in chalk. The relatively small diameter core so far studied (Figure E2) may be a partial cause of the almost complete destruction of the chalk sections of core using the sonic method. Larger diameter coring may be part of the answer. Conventional cores from a borehole nearby and from similar depths illustrate the presence of structured chalk throughout (Figure E3).
