7 BELL ROCK the start of the Stevensons

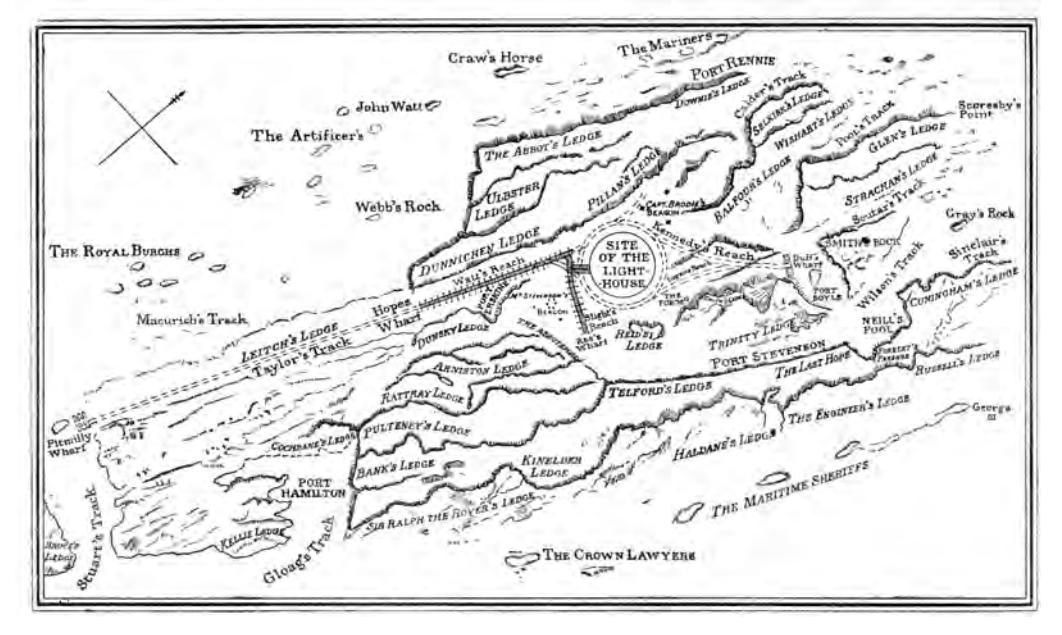
Left: One of Stevenson's early plans of the Bell Rock showing the site of his proposed lighthouse, the cast-iron tramways he proposed to build, and the site of his beacon. Many of the names given to the ledges, tracks and channels were those of the workman building the light.

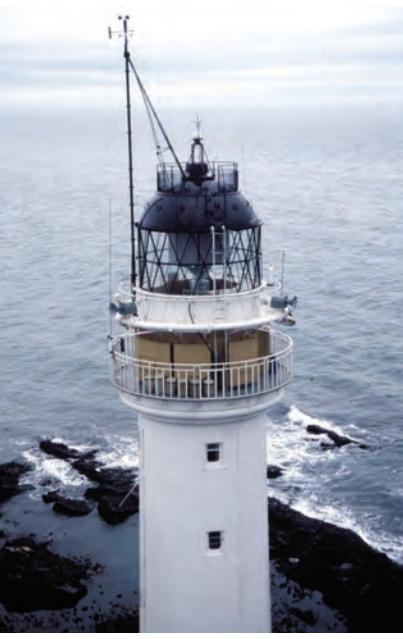
Left: This view of the lantern from an NLB helicopter shows exactly how the previous photograph was taken The ladder to the weather vane and anemometer leans against their support, although a head for heights was clearly needed if any work was to be done on the instruments. Bell Rock used to be a Met Office coastal reporting station. (Author)

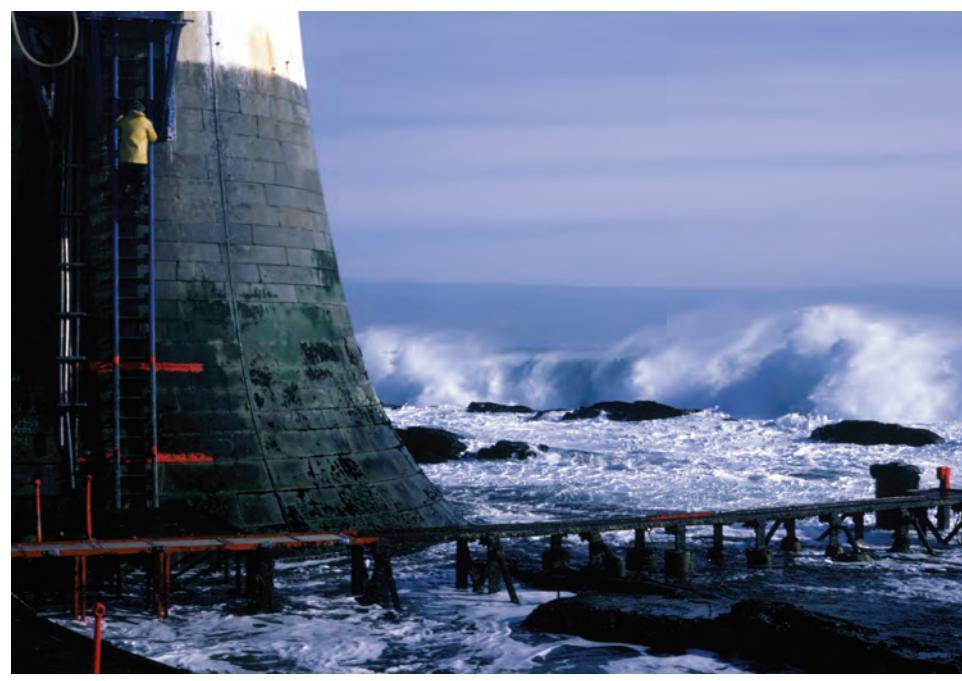
Above: Huge rollers break against the Inchcape Rock from the east. The iron walkways are seen to good effect in this shot. (*Jim Bain*) This is not the only time that the name of Stevenson occurs in this volume. Indeed, the Bell Rock heralds the start of an era of lighthouse construction around Scottish waters that is dominated by the Stevenson family. Many of Robert's descendants maintained the standard set by their father to build towers whose beauty and grace equalled, if not exceeded, that of the Bell Rock. Trinity House boasted that the name Douglass was connected with its finest works, while north of the border the Stevenson family reigned supreme, acclaimed by all who knew their work as the finest lighthouse engineers throughout the world.
